HANOI LAKES REPORT 2015

The Vietnam Environmental Protection Fund and the Center for Environment and Community Research have developed the *"Hanoi Lakes Report 2015."* The 2015 updated report focuses on the current status of the Hanoi lakes five years after the first report was published. The report includes results and recommendations for more in-depth research on some specific lakes, an assessment and analysis of policies related to Hanoi lakes's management and protection, identification of challenges and barriers that currently prevent the restoration and long-term management of lakes and wetlands, sharing of experiences of community participation in lake protection and long-term recommendations for future Hanoi lake protection.

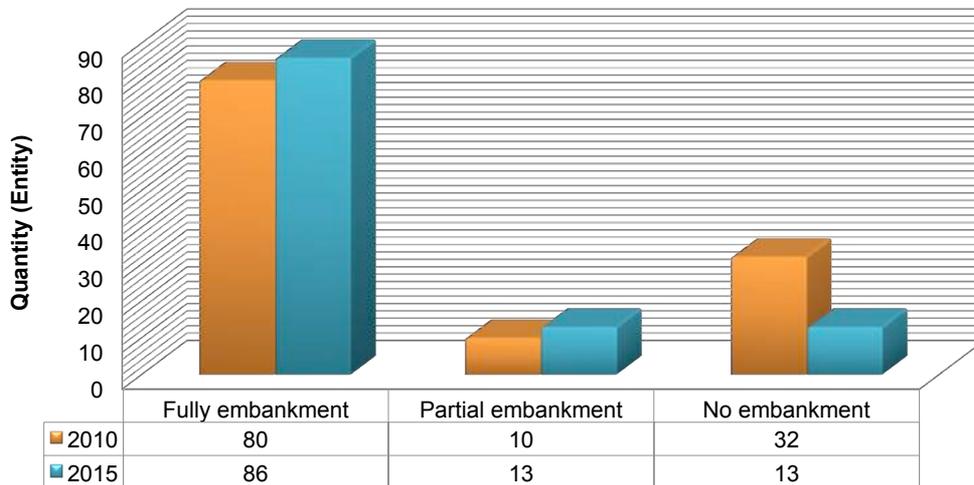
Figure 3: The changes on the structure embankment of lakes

Figure 3, 4 and 5 show the changes on the structure embankment and environmental status of Hanoi ponds and lakes from 2010 – 2015 below:

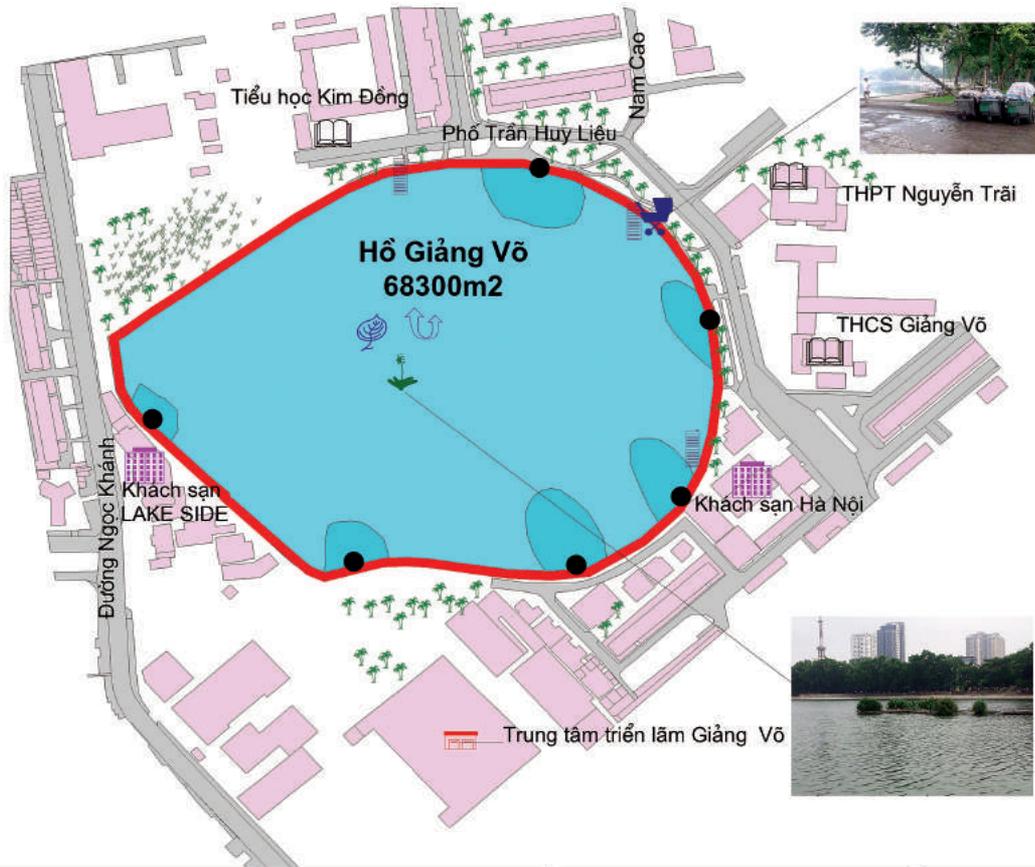
GIANG VO LAKE

CHÚ GIẢI			ĐV QUẢN LÝ		 TỶ LỆ: 1:4500 TỌA ĐỘ: 105,83;21,03 ĐỊA CHỈ: Trần Huy Liệu Giảng Võ, Ba Đình
Thang bộ xuống mặt nước	Nhà	Nước ô nhiễm rất nặng	Đơn vị quản lý địa giới hành chính: UBND Quận Ba Đình		
Bãi tập kết rác	Bè thủy sinh	Nước ô nhiễm nặng	Đơn vị quản lý an ninh trật tự ven hồ: UBND Phường Giảng Võ		
Cây xanh	Kè toàn bộ	Cổng xả thải	Đơn vị quản lý vệ sinh ven hồ: Công ty Hà Thủy		
Bụi cỏ	Điều hòa	Đường	Đơn vị quản lý chất lượng nước: Xí nghiệp thoát nước số 4		
Quán cóc ven hồ	Cảnh quan

In 2015, some parts of embankment have been degraded but not yet repaired.

The status of embankment and corridor is similar to the 2010 status. However some parts of embankment are degraded and there is a big garbage-gathering yard and 2 lakeside refreshment stalls.

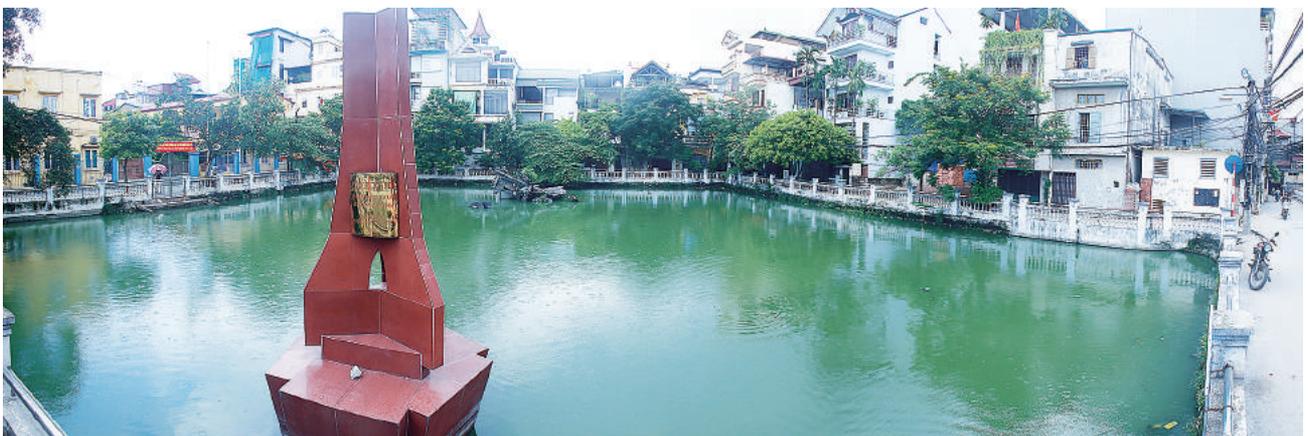
Lake water is green-colored, turbid, and quite foul. B-52 aircraft wreck in the lake is rusted and severely degraded. Lake fauna consists of fish, shrimp, and pupa. Flora is mostly green algae.

Improve water quality and preserve the B-52 aircraft wreck from not becoming degraded.

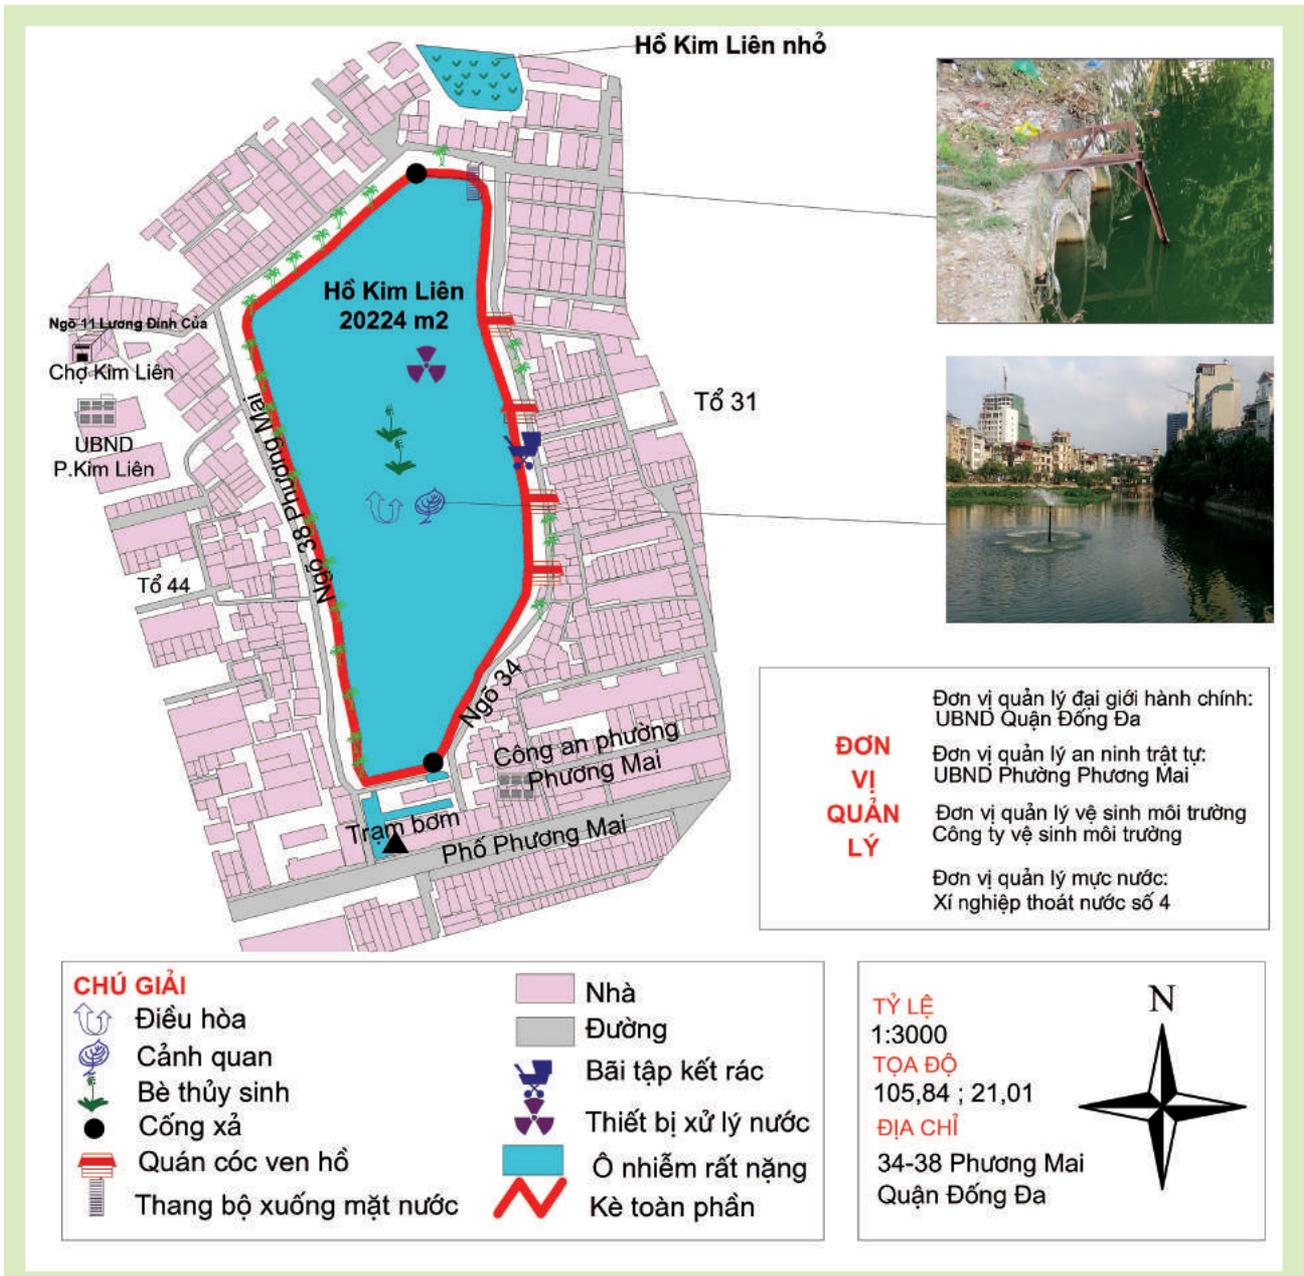
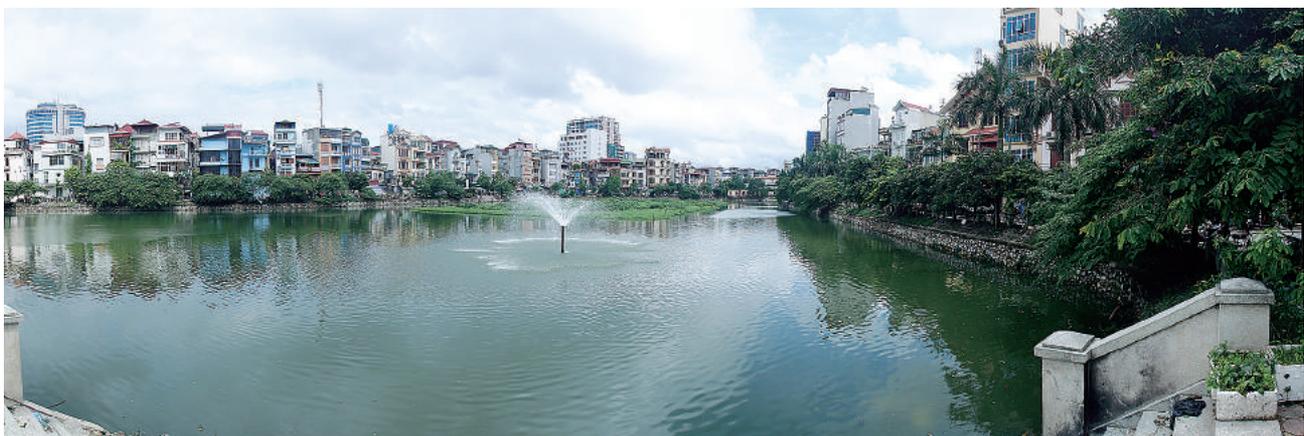
KIM LIEN LAKE

In 2015, the large Kim Lien lake's shore has no construction materials due to the renovation being completed. However, dumping garbage at the area of lake still occurs. The scene of water area is degraded; weeds and water hyacinth cover nearly completely the surface of the big lake. Result of the water analysis in 2015 shows the lake water quality decreases compared to 2010. The lake is heavily eutrophicated and polluted by organic substances.

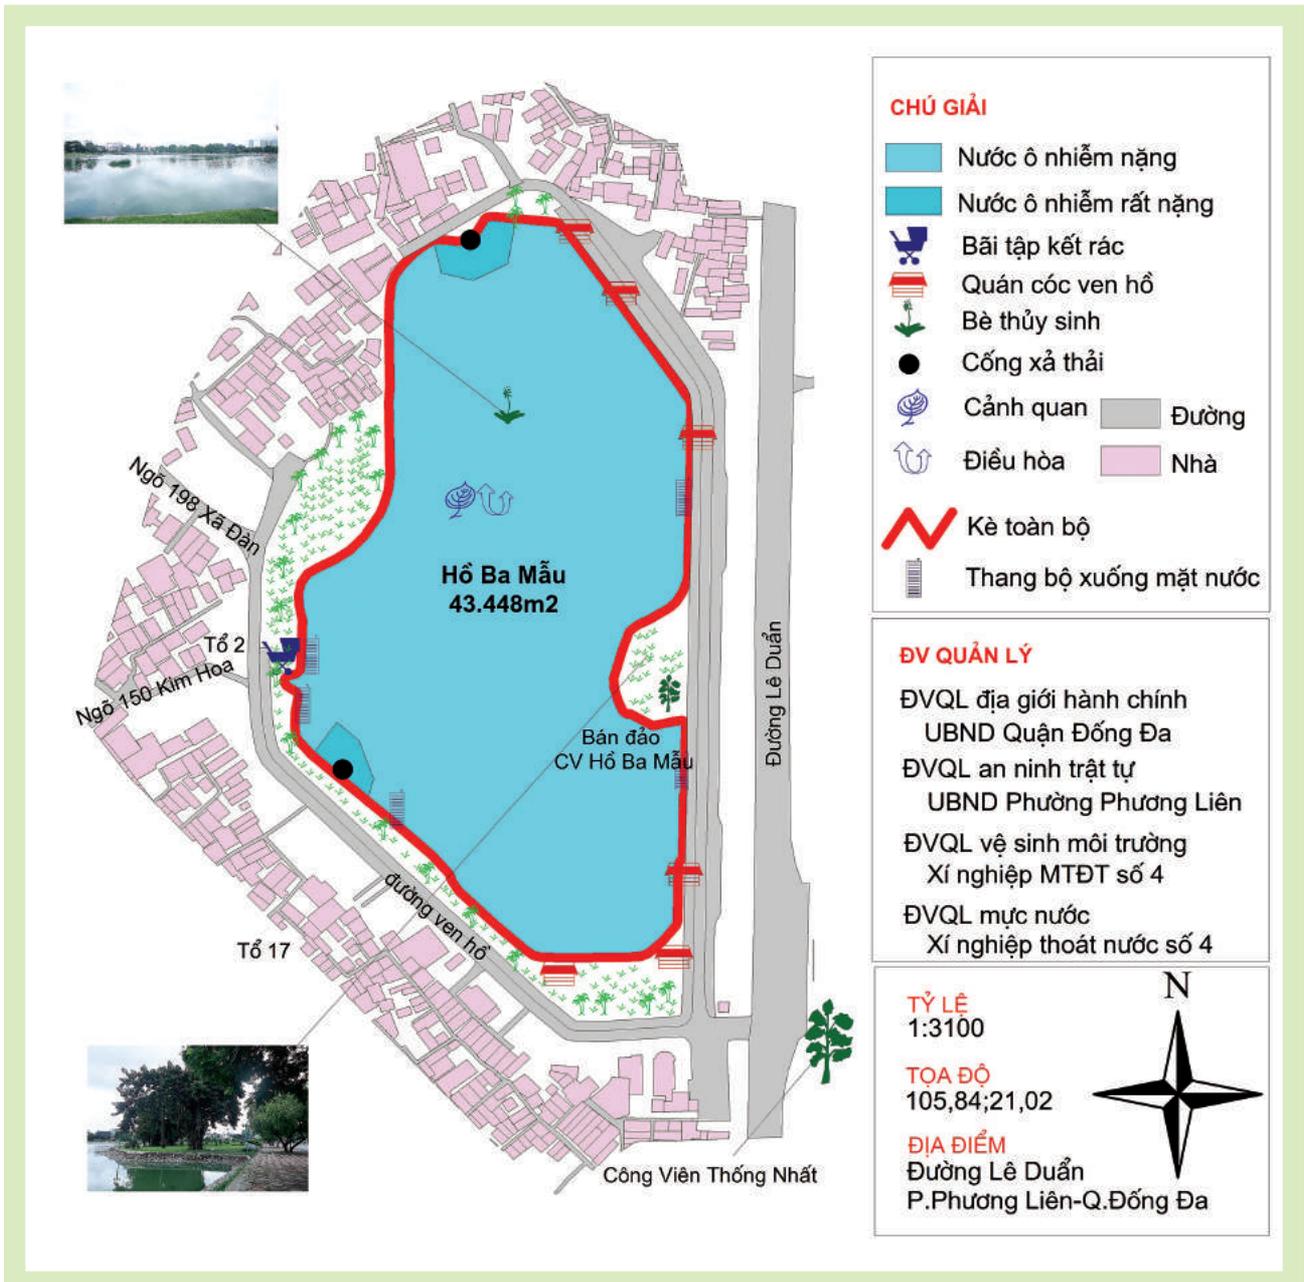
BA MAU LAKE

In 2015, some parts of the embankment and stairs are degraded and unsanitary.

The status of embankment and shore corridor is similar to that of 2010. However, some parts of the embankment and stairs leading to the water are degraded and unsanitary due to garbage and defecation. The shore corridor is encroached by refreshment stalls, parking lots and garbage-gathering yards.

Take measures to return space to the lake corridor,
 Repair the embankment, stairs leading to the water,
 Strictly prohibit the discharge into the lake.

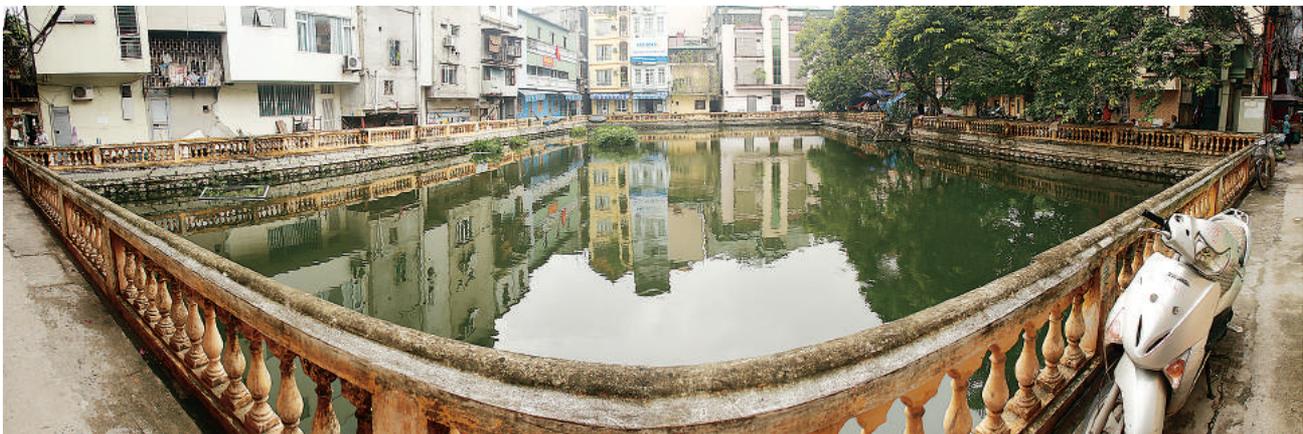
VUONG LAKE

The lake receives domestic wastewater from leaking pipes of some households and garbage from the lakeside temporary market.

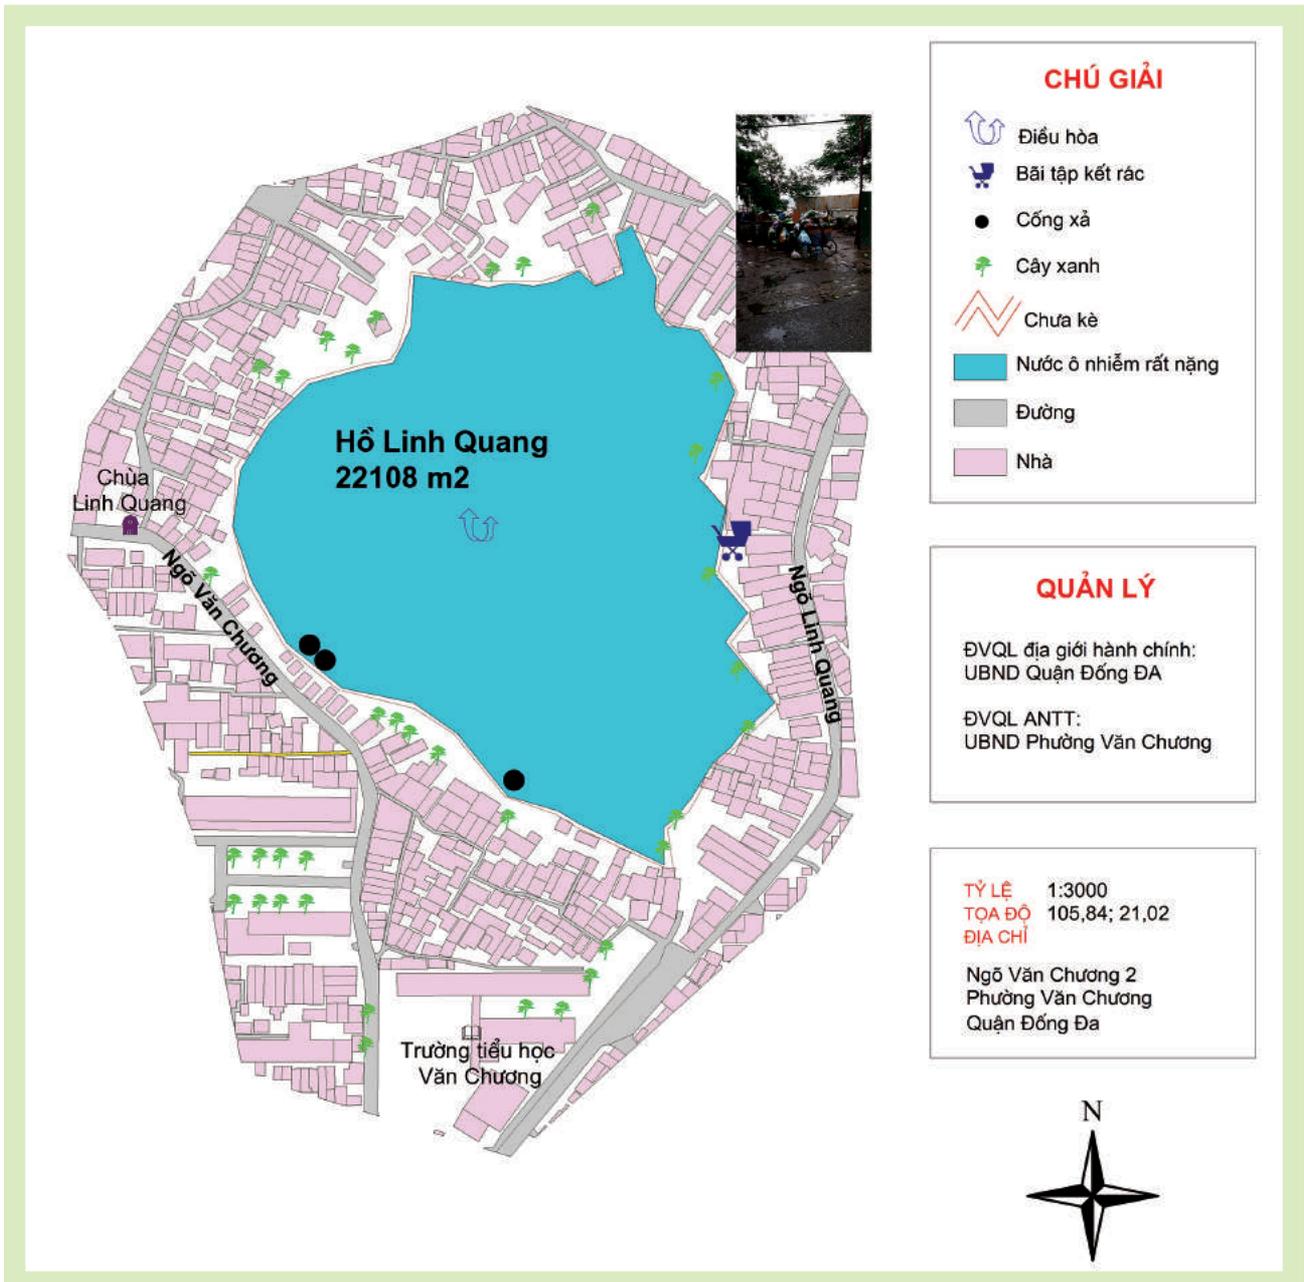
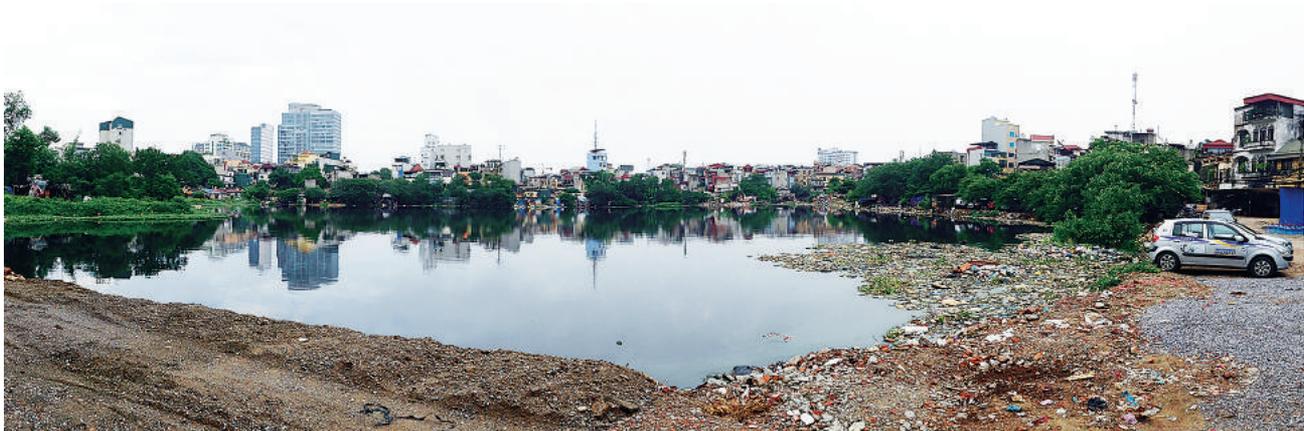
LINH QUANG LAKE

In 2015, the scene of the shore and water area has degraded seriously. Results of the water quality analysis show that the lake is polluted by organic substances and has a strong growth of algae.

Lake water has turned dark – colored, fetid smelled, the lake surface is covered completely by waste and weeds. The reason for this condition is that thousands of surrounding households daily discharge wastewater into the lake. Besides, many people used vans, carts, and took advantage of night to dump construction waste into the lake. The encroachment of Linh Quang lake is upsetting the public. Previously the lake had an area of about 2 hectares, now it is only a small pond. As soon as the lake is encroached, stalls, temporary markets, car parking “grow” ...

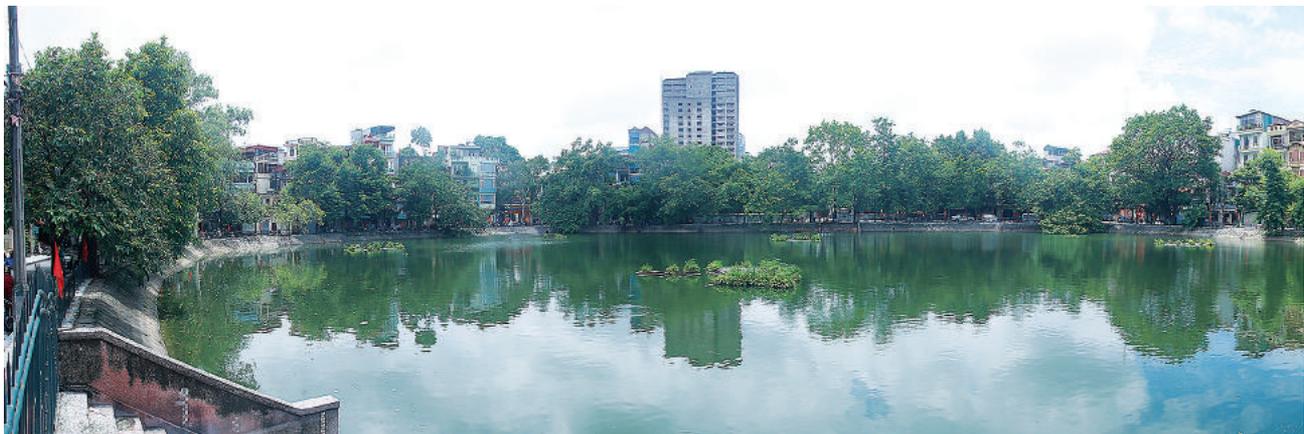
HAI BA TRUNG LAKE

The condition of the embankment and shore corridor is similar to those in 2010. Soil of the embankment is used by people to plant vegetable. The sidewalk is free of garbage.

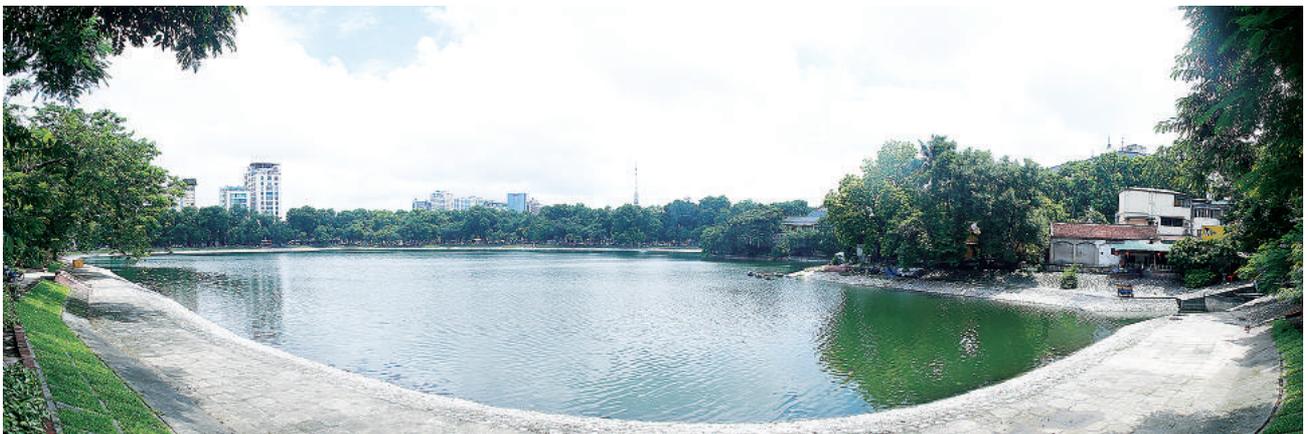
Lake water is green-colored, fishy, has algae. There is a small amount of garbage including plastic bags and fallen leaves on the surface, especially on the water near the sewer. The lake has phenomenon of fish mass mortality in summer but its cause has not been determined.

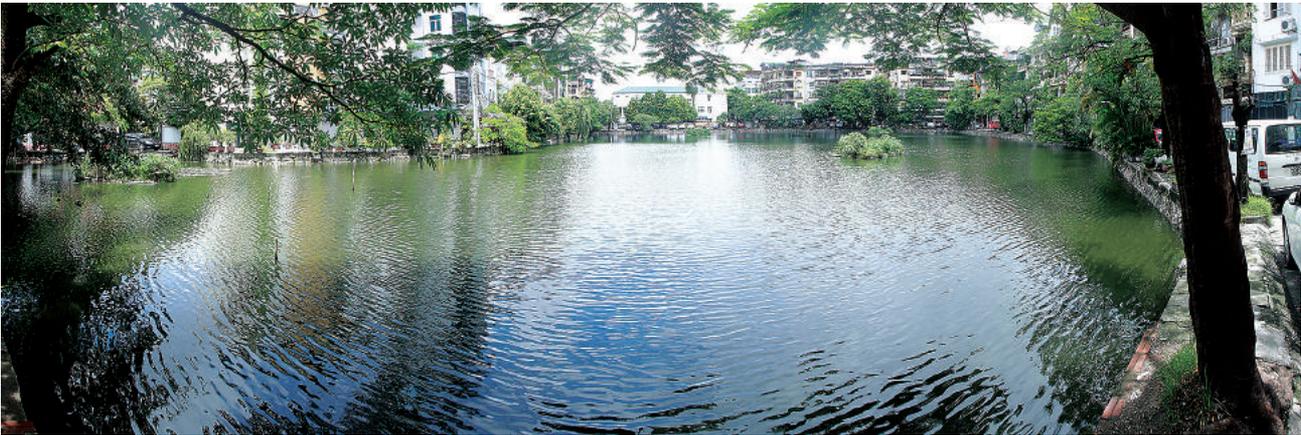
Water is opaque green, has bad smell, many algae, dead fishes and plastic bags are observed. The lake has four rafts of aquatic plants. Fishes are plenty, attracts many people to come fishing.

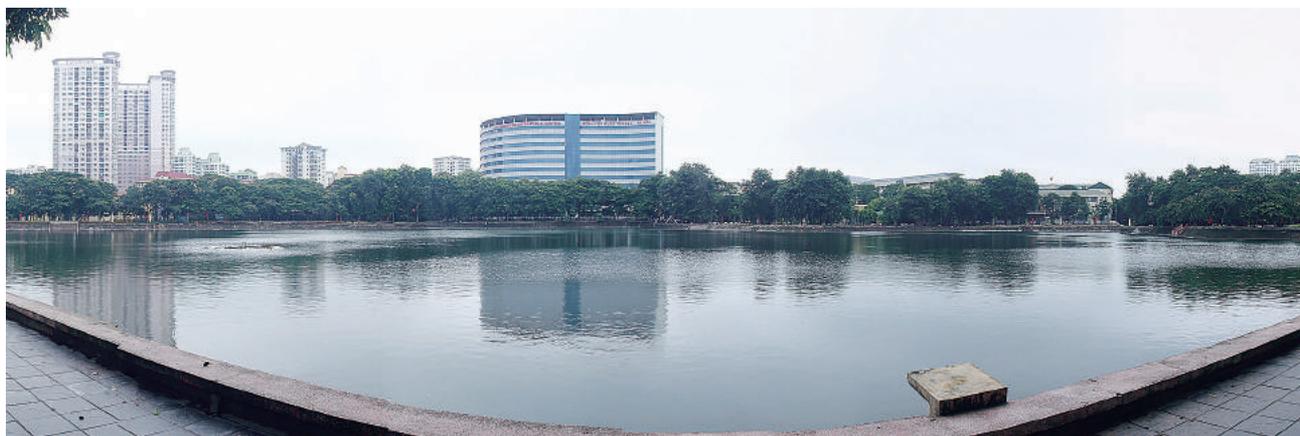
NGHIA TAN LAKE

Since the project of lake renovation has not been implemented, the status of lakeshore is still being degraded with serious pollution. The side at Xuan Dieu street is filled with garbage from households and small business establishments. On the lakeshore, there were ten small stalls, snack restaurants, tents. The lakeshore opposite to Xuan Dieu street is adjacent to residential areas with no stall.

The renovation project has been suspended since 2010 making local communities feel pressing. Results of the water analysis in 2015 show that the lake was contaminated with organic matters and algae. Lake landscape is degraded, many stalls are likely to expand.

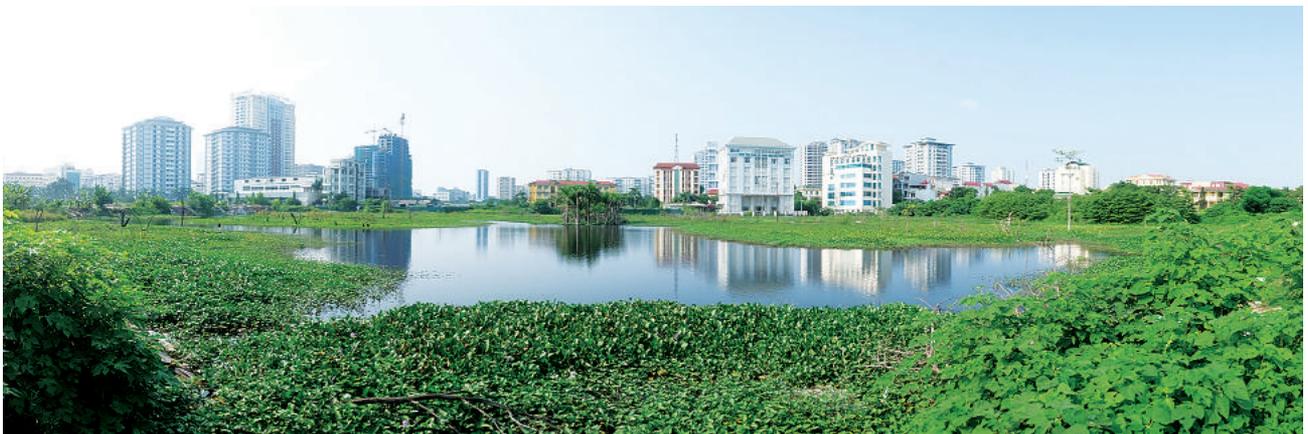
Sanitary condition has not improved since 2010; the pond continues to be encroached. Water surface near the shore contains lots of plastic garbage, construction and domestic wastes.

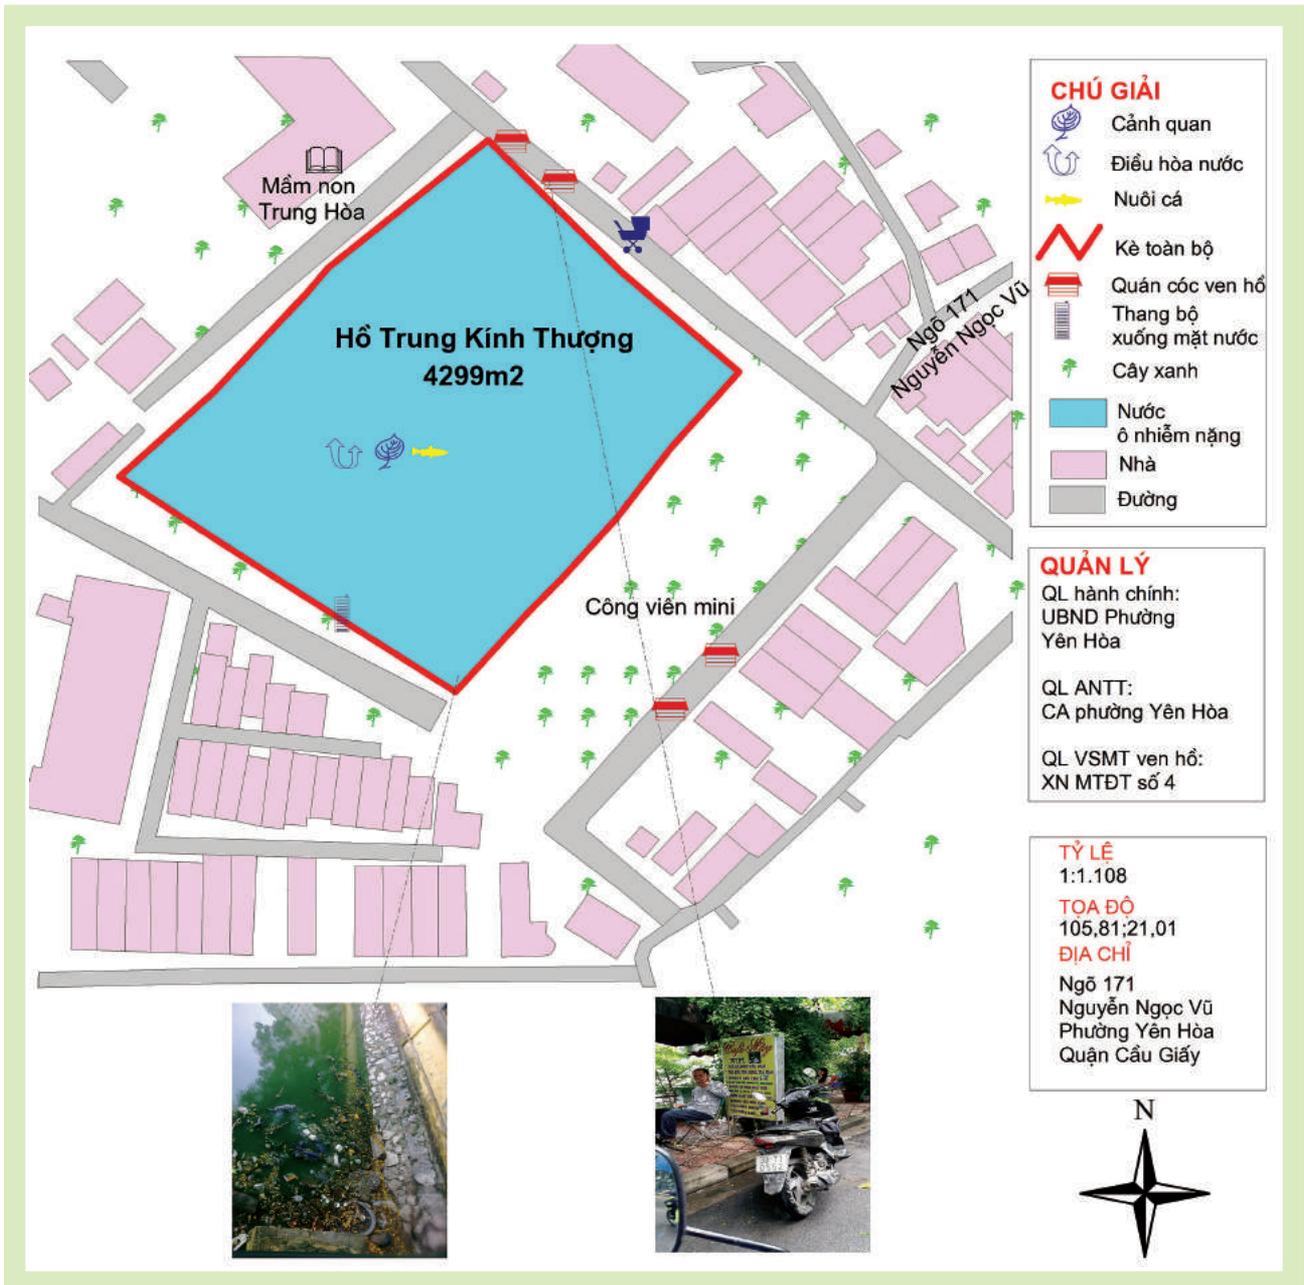
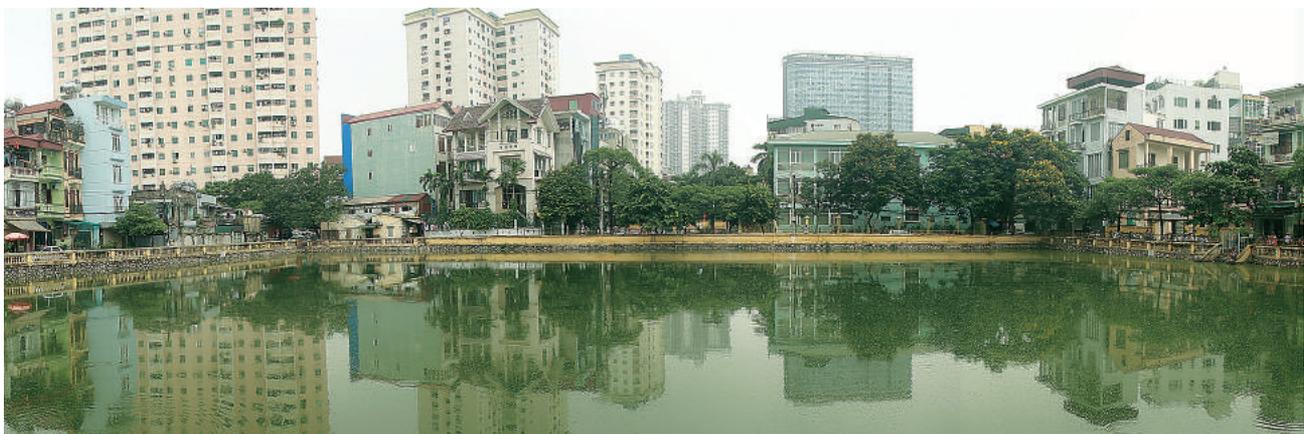
TRUNG KINH THƯƠNG LAKE

This is one of the newly added lakes to the survey in 2015. The lake is in the Trung Kinh Thuong village, which is located in lane 171, Nguyen Ngoc Vu St., Yen Hoa ward, Cau Giay district. It has function in landscaping and regulating water in the region. Currently, the private sector is invested in the lake for fish farming.

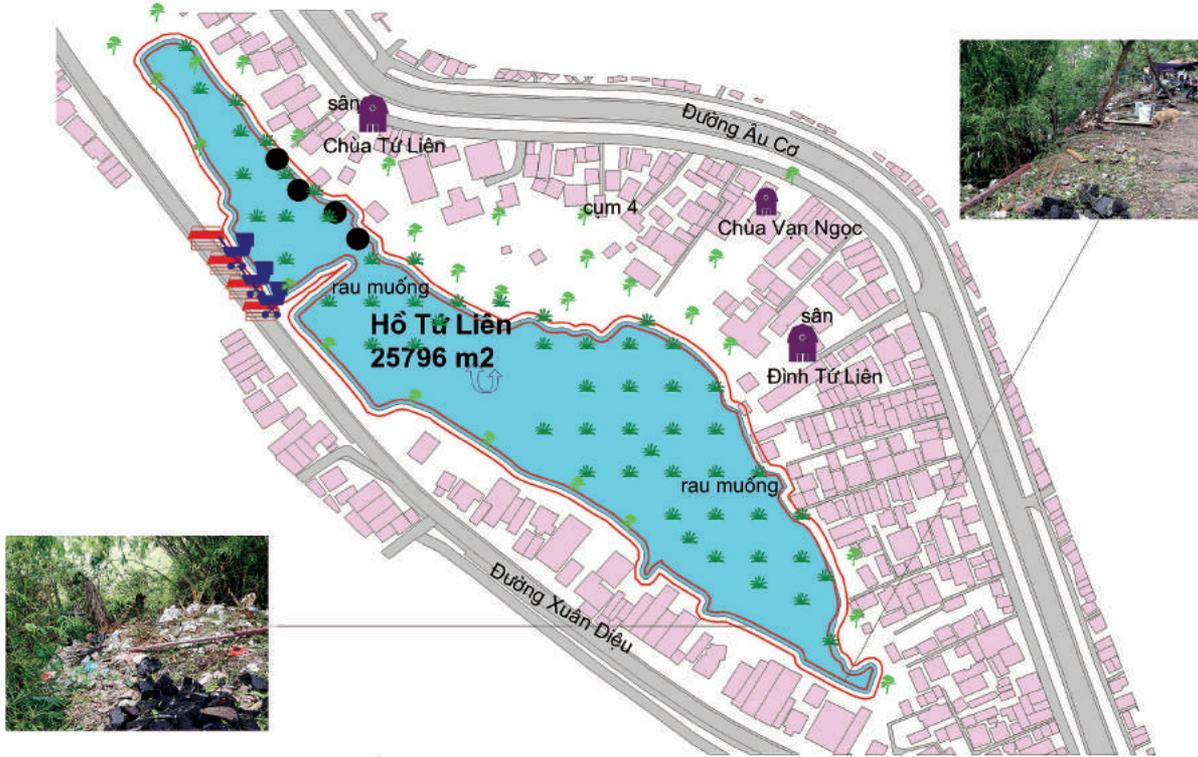
TU LIEN LAKE

The renovation project has been suspended since 2010 making local communities feel pressing. Results of the water analysis in 2015 show that the lake was contaminated with organic matters and algae. Lake landscape is degraded, many stalls are likely to expand.

Since the project of lake renovation has not been implemented, the status of lakeshore is still being degraded with serious pollution.

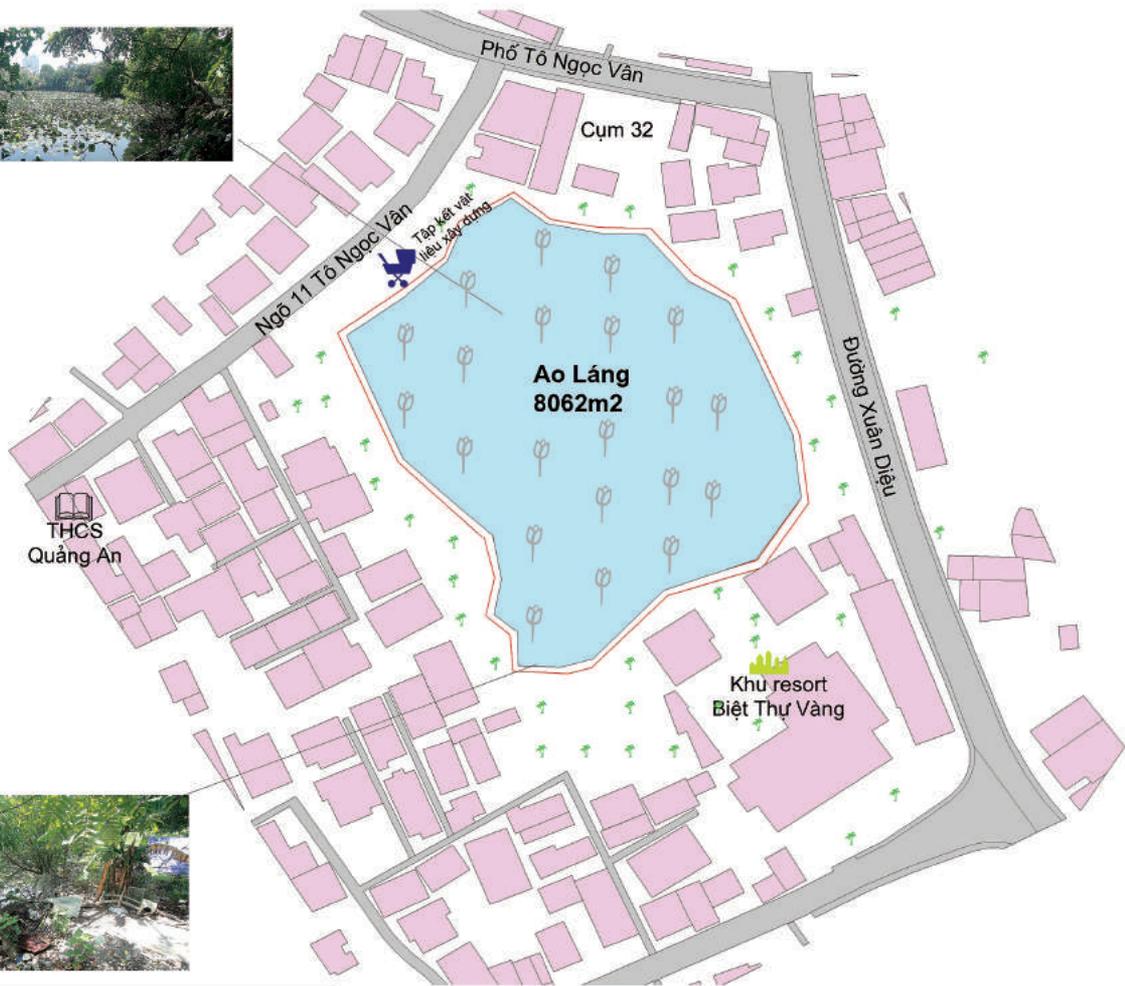
LANG POND

Water quality has not improved. Water is moss-green, has bad smell, more white bubbles appeared, green algae, yellow algae. Plants are mainly lotuses, duckweed. Despite lotus planting, the landscape is still degraded due to large amount of garbage.

There should be solutions to prohibit encroachment of corridor, pond's shore and surface water.

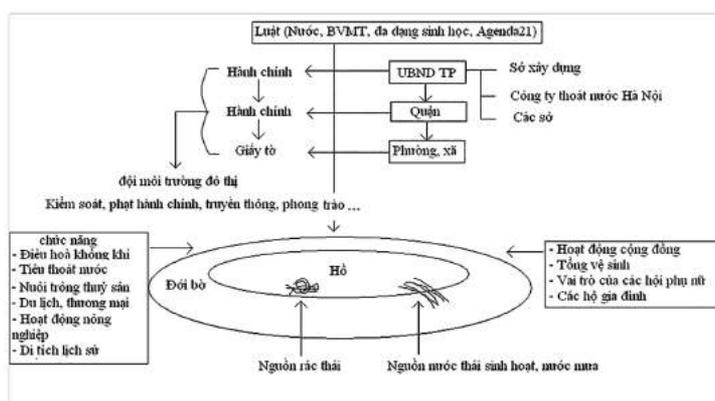
From the diagram, in order to manage and protect the ponds and lakes in Hanoi there are a system of laws, rules and legislation that involve all levels of management authority, from the People's Committee (PPC) of Hanoi, to PPC of districts, communes, and sector Departments. This management system follows a top-down approach and is relies heavily on controlling and sanctioning. Each pond or lake has many functions and features that are managed by several different agencies. In terms of ecology, every lake has a particular aquatic ecosystem and this ecosystem cannot be separated. The fact that multiple parties manage one lake is contradictory to the conservation of lake ecosystems. Current mechanisms cause conflict in management of lake water and the lakeside corridor. This approach is the biggest challenge in the conservation of lake ecosystems, leading to the degradation of the landscape, water regulatory functions, and the environmental function of the lake.

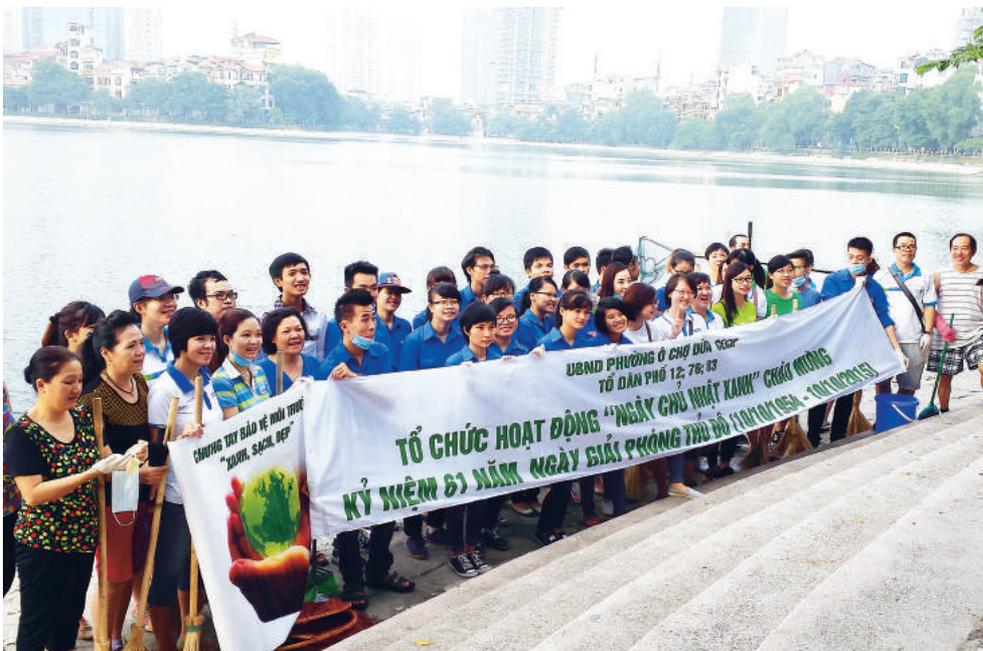
People Group 76, O Cho Dua Ward pioneers in protecting Dong Da Lake

Dong Da Lake is a lake in Dong Da District and it has border with O Cho Dua Ward and Trung Liet Ward. Workers from Ha Thuy Co. are responsible for maintaining sanitation conditions around Dong Da lake, but the cleaning is not done thoroughly. The area and the lake suffer a lot of trash and smell by water pollution.

People Group 76, a group located near to Dong Da lake, to improve this problem: 76 households worked together to organize cleaning up the surrounding of the lake twice a month. The goals of the community are to keep lake clean timely, increase awareness for lake protection for future generations and to promote attitude change of people. The habit of littering of the people living around the lake has been increased steadily since 2014. Thanks to these efforts most households now enjoy clean street and lake area.
